**SAS Superstructure**

Location: 04-SF-80-13.2 / 13.9

Daily Diary Report by Bid Item

Diary #: 305 Const Calendar Day: 984 Date: 19-May-2012 Saturday

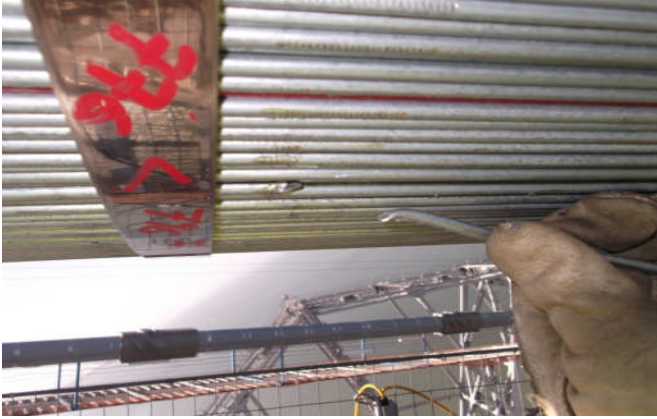
- From 08:00 until 09:15, Tony's crew was un-installing the CB at PP34N. After the CB was removed, it was noticed that there is one broken wire near the bottom of the Cable in the area that was near the uphill edge of the CB. Also, several of the CB bolts had some galvanizing damage. See attached photos. I called Roman Granados to inform him of these details.

Broken wire in the CB area at PP34N

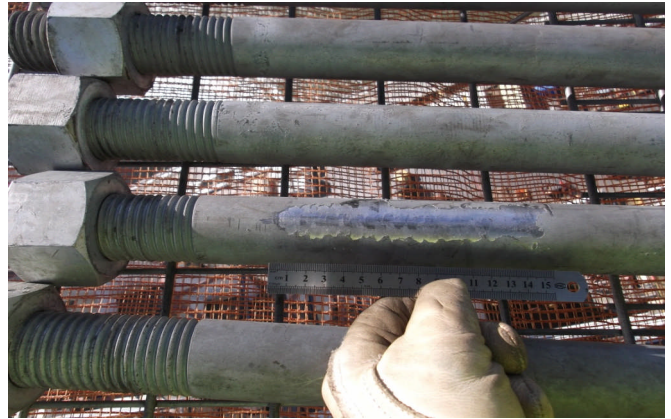
Galvanizing damage to CB bolt at PP34N

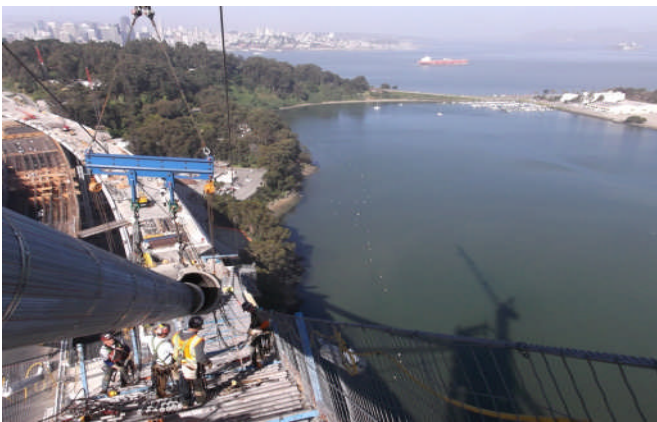
Un-installing the Cable Band at PP34N

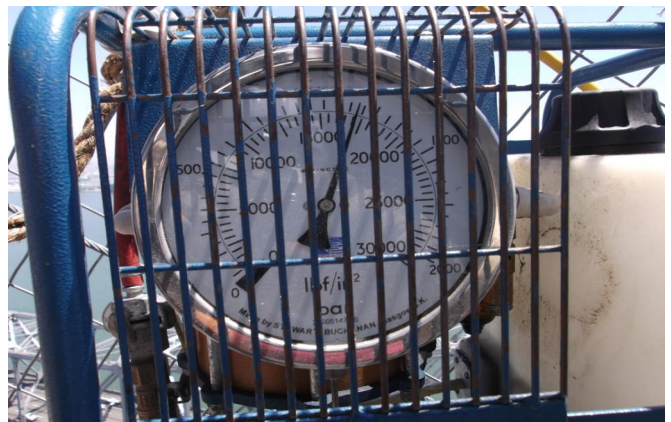
- Note on CB tensioning: At no point in during the bolt tensioning did the jack pressures exceed 17,400 psi.
- From 15:15 until 15:30, I helped Saman & Laraine take some measurements on the installed CBs in the South main-span.

Pressure gauge at 17,400 psi at the end of CB bolt tensioning
